**Flood Control Project Maintenance
Levee Inspections**

Maintenance Issue Types Only, Levee Inspection Report By Mile - Spring 2019

Levee District No. 0009 (Sutter County)

Waterway	Bank	Unit Miles	Inspection Start/End	Inspector
Unit No. 01 Sutter County, Feather River	Right	6.25	04/12/2019 04/12/2019	Sterling York

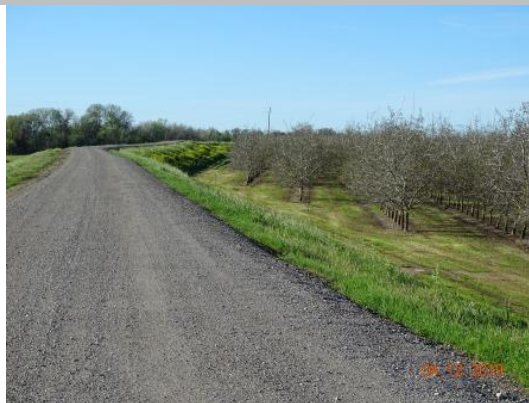
Photo 1 of 1 : SP_2019_LD0009_202_1_20190415_00003.jpg

LM Start	0.00	Rating **	M	Issue No.	1
LM End	6.23	Issue Type +	Ma	Location *	LS
Category	Earthen Levee			GPS Latitude/Longitude	
				Start	End
Item	Vegetation			39.168827 °	39.255559 °
				-121.622585 °	-121.636350 °
DWR ID	DWR_LD0009_01_s_2019_1				
Comment Code					
V1 : Control annual grass and weeds on the levee slopes and easements.					
Inspector Comment					
The annual vegetation is too high to be able to see any new issues and should be maintained before the fall inspection.

View looking downstream landside at the annual vegetation that needs to be better maintained, Spring 2019.

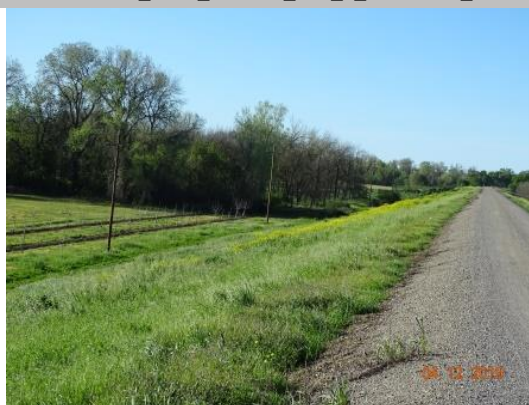
Photo 1 of 1 : SP_2019_LD0009_202_2_20190415_00004.jpg

LM Start	0.00	Rating **	M	Issue No.	2
LM End	6.23	Issue Type +	Ma	Location *	WS
Category	Earthen Levee			GPS Latitude/Longitude	
				Start	End
Item	Vegetation			39.168827 °	39.255559 °
				-121.622585 °	-121.636350 °
DWR ID	DWR_LD0009_01_s_2019_2				
Comment Code					
V1 : Control annual grass and weeds on the levee slopes and easements.					
Inspector Comment					
The annual vegetation is too high to be able to see any new issues and should be maintained before the fall inspection.

View looking downstream waterside at the annual vegetation that needs to be better maintained, Spring 2019.

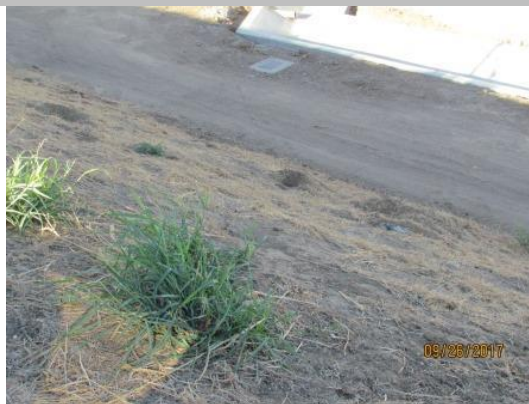
Photo 1 of 1 : SP_2019_LD0009_202_18_20190305_00001.jpg

LM Start	0.09	Rating **	M	Issue No.	18
LM End	0.09	Issue Type +	Ma	Location *	LS
Category	Earthen Levee			GPS Latitude/Longitude	
				Start	End
Item	Animal Control			39.170064 °	39.170064 °
				-121.622563 °	-121.622563 °
DWR ID	DWR_LD0009_01_f_2016_18				
Comment Code					
A3 : No rodents visible, but rodent burrows visible; need to backfill and compact or grout burrows.					
Inspector Comment					
No rodent activity was observed, holes need to be backfilled. Fall 2018

View on landside of rodent activity and holes.
